# TESTING OF POLYIMIDE SECOND-STAGE ROD SEALS FOR SINGLE-STATE APPLICATIONS IN ADVANCED AIRCRAFT HYDRAULIC SYSTEMS

by A. W. Waterman

May 1977

Boeing Commercial Airplane Company  
P.O. Box 3707  
Seattle, Washington 98124

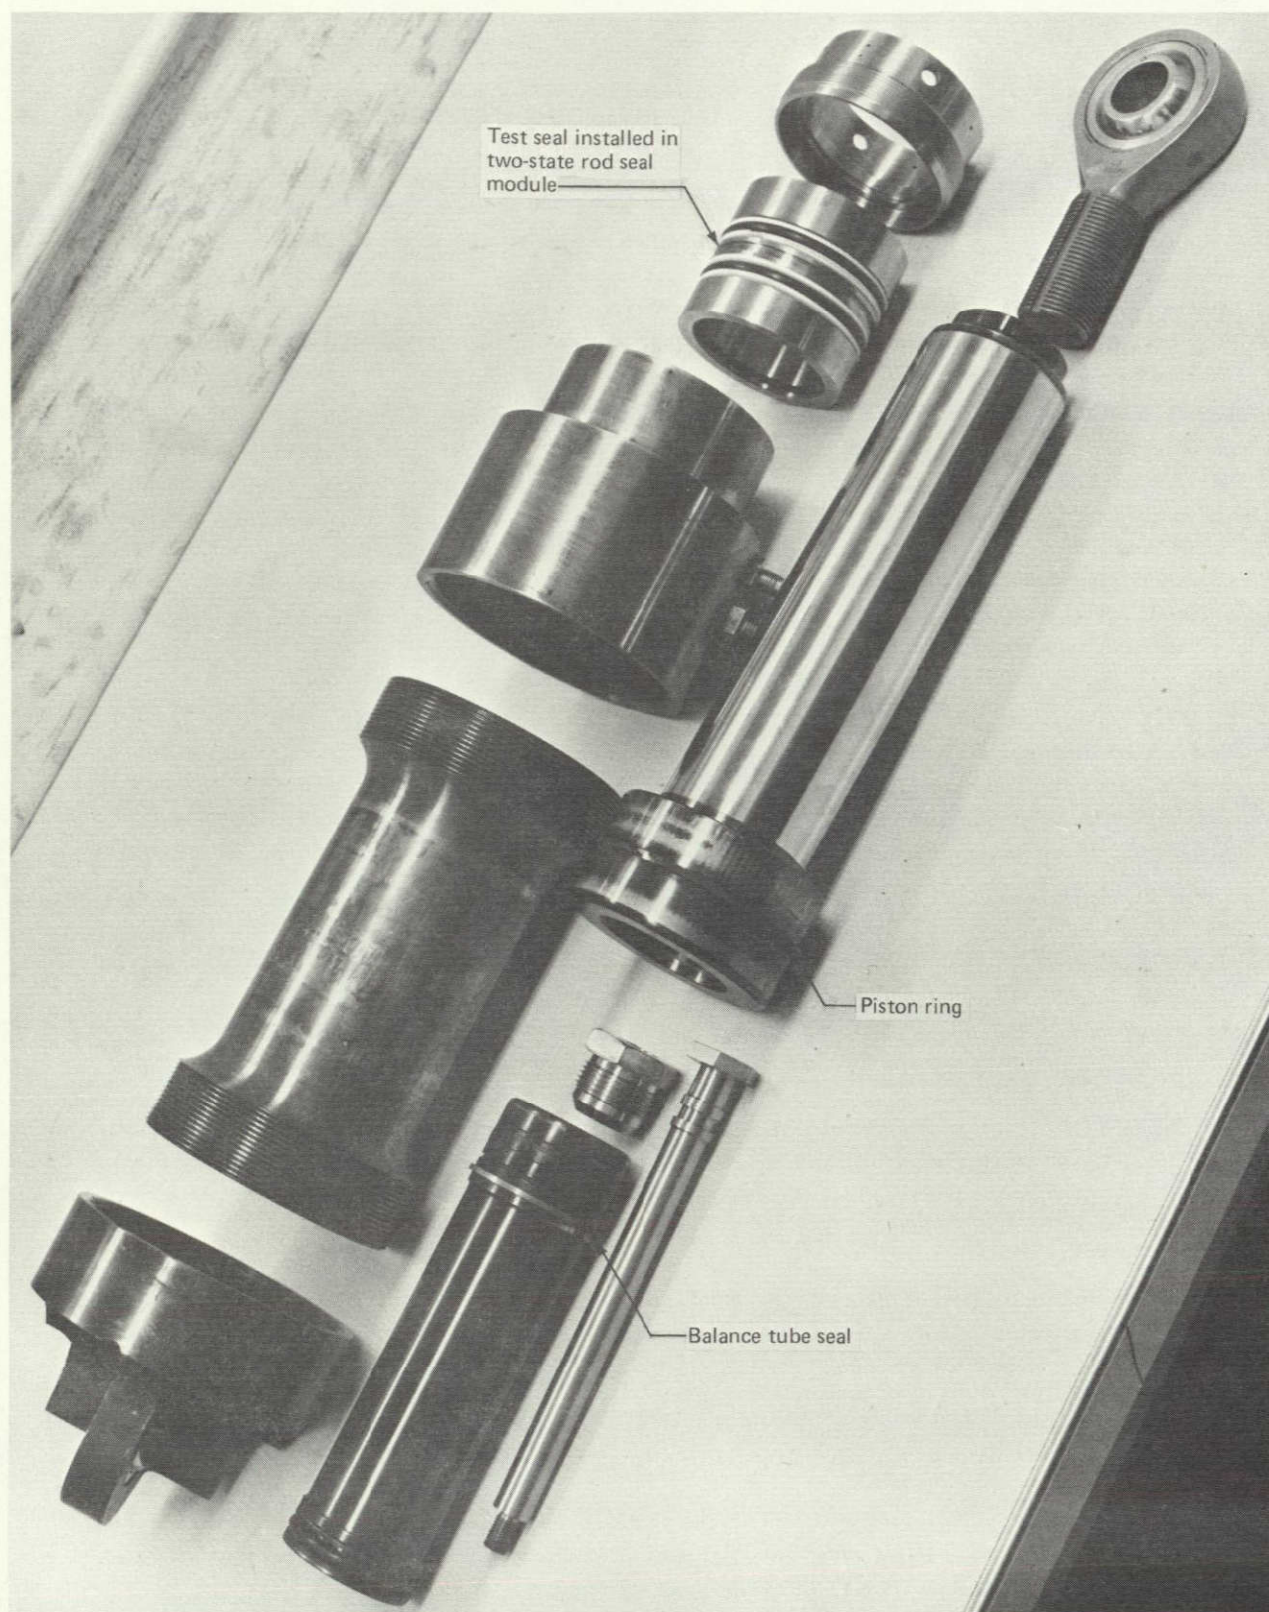
Figure 11.—6.35-cm (2.5-in.) Endurance Test Actuator

The above conditions are suspected of being the cause for leakage developing at the balance tube seal which lies within the actuator rod (fig. 11).

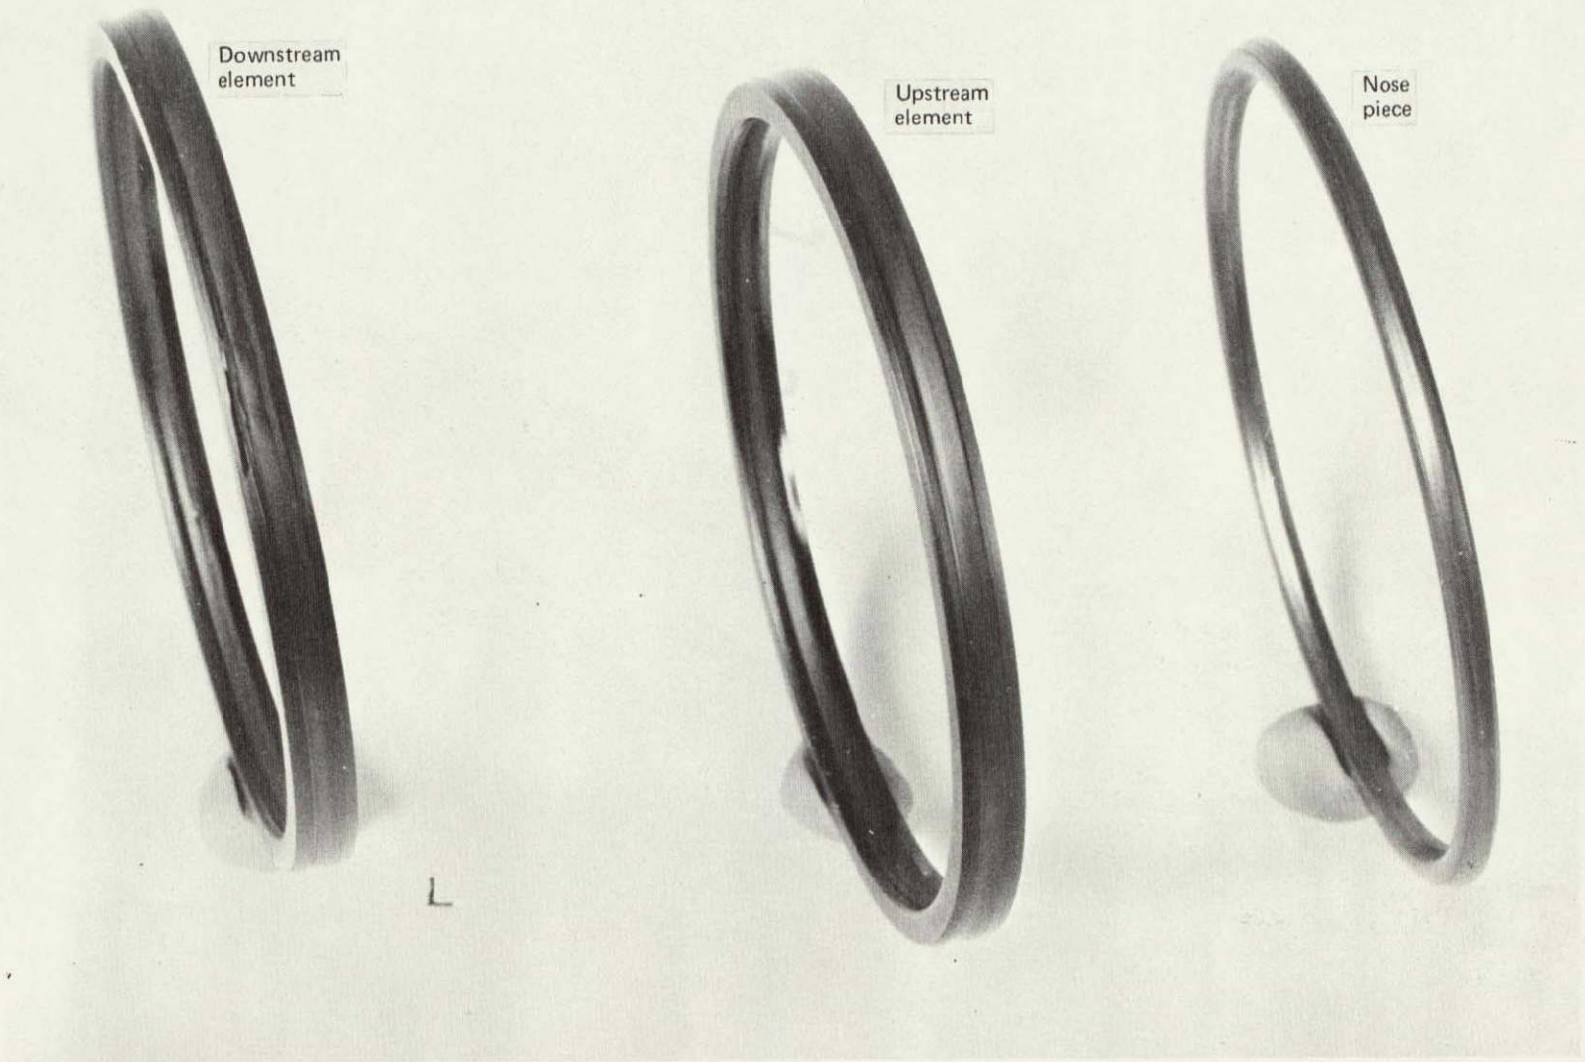
Figure 16.—Endurance Test Seals

Posttest inspection of the seal elements under test (fig. 16) showed the following:

- Upstream element (fig. 17)
  - The od leg was slightly polished on the sealing surface.
  - The id leg was highly polished on the sealing surface, this extending farther back on the leg than the machined sealing flat. The id leg was cracked 160° of the circumference, but the crack did not sever the leg.
- Downstream element (figs. 18 and 19)
  - The od leg had a crack 170° of circumference that did not sever the leg. A second crack in the support block section of the K geometry was 10° in seal circumference and did penetrate through the cross section (see fig. 18).
  - The id leg was cracked approximately 180° of the circumference, and the sealing lip was chipped and worn to a very thin cross section (fig. 19).

These seals, with the fractures as described, could not be successfully reinstalled in the actuator for further testing. The presence of the structural cracks indicated that their life expectancy, if the test had not been stopped, was not very long.

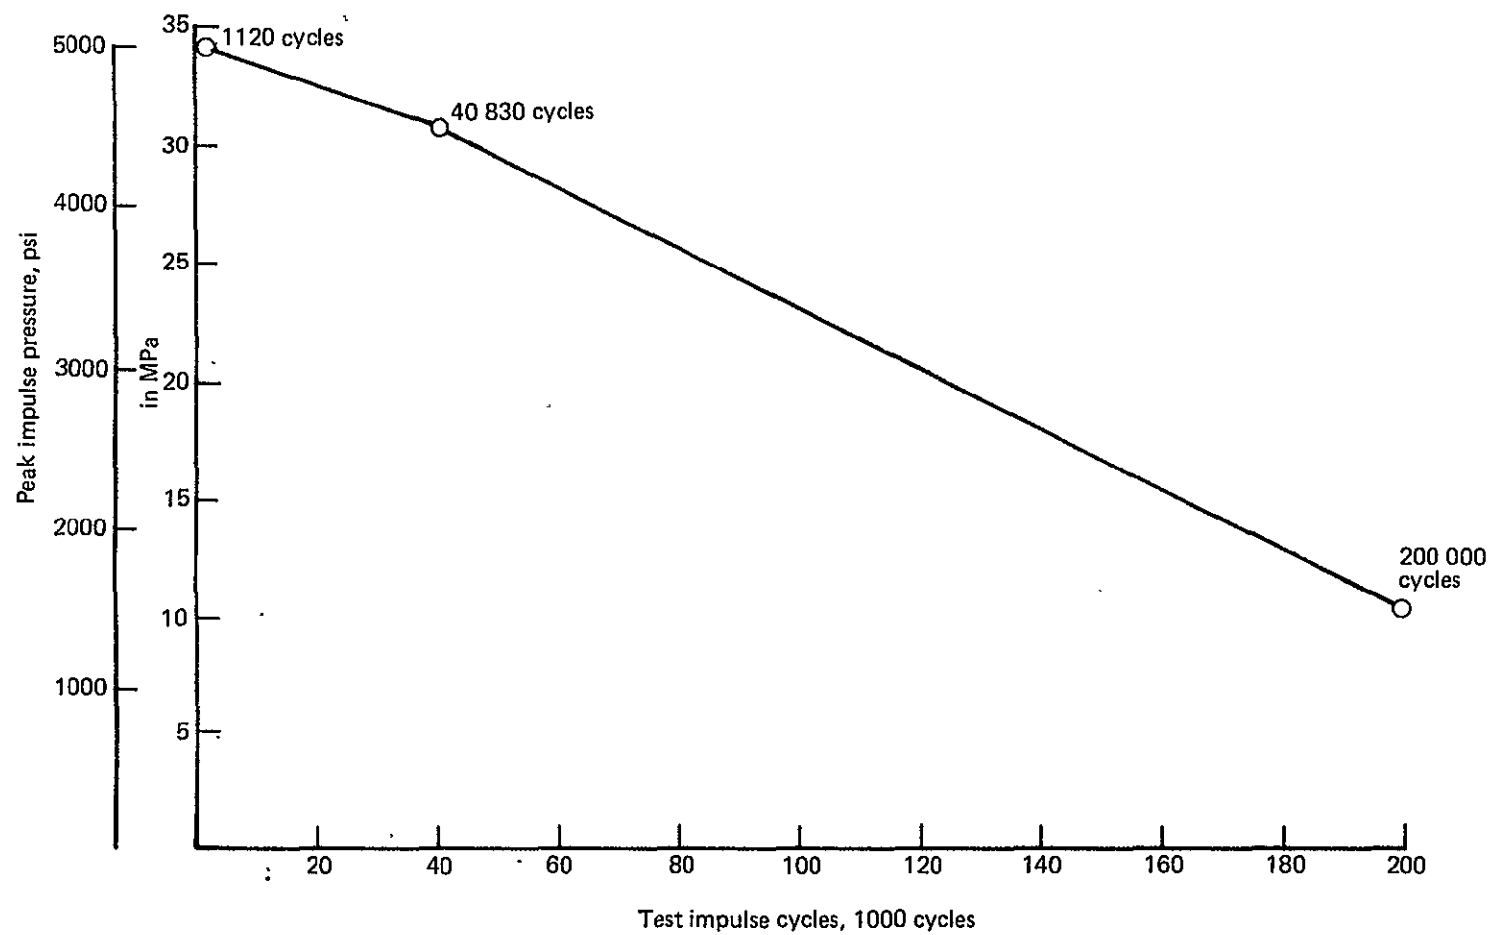
Figure 20.—Projected Impulse Life

The best analysis that can be made of impulse life of the K-section seal as a function of peak impulse pressure applied to the seal is by comparing the largest number of cycles obtained in testing at various pressures. This life is shown in figure 20 and is a pessimistic analysis of the seal capability because the data points at 31.030 MPa (4500 psi) and 34.478 MPa (5000 psi) were obtained with seals that had had previous testing, and the data at 10.43 MPa (1500 psi) was not a failure condition for the seal. To obtain a true picture of impulse life, multiple samples at selected pressures would have to be tested. To arrive at an estimated life at each pressure, nonrepresentative results would be eliminated by statistical analysis.
